November 2019
Fuji Electric Co., Ltd.
Hakko Electronics Co., Ltd.

Defect Report: V-SFT Software

MONITOUCH configuration software V-SFT-6/V-SFT-5

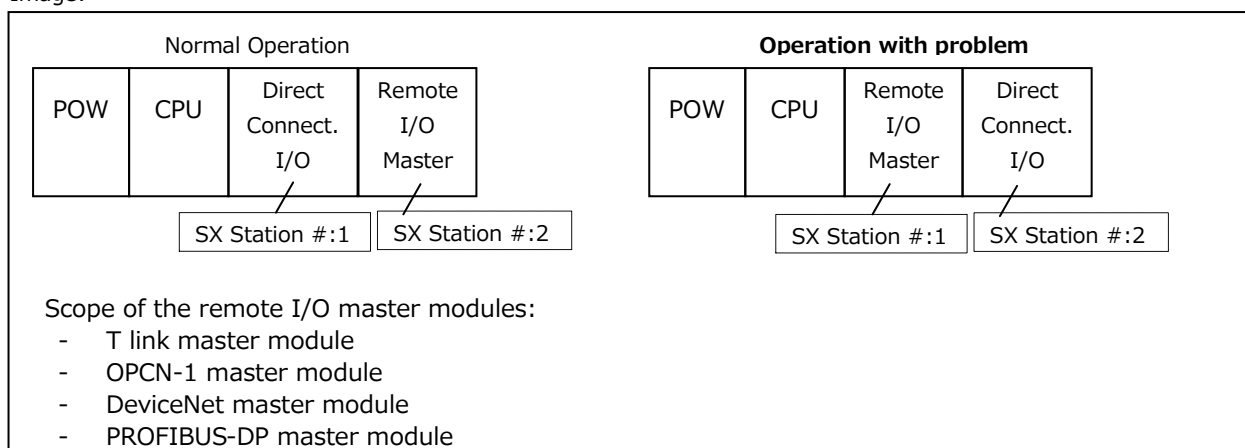
X/Y device control and monitoring are not available when connecting a MONITOUCH HMI to the Fuji Electric PLC "MICREX-SX" model.

- 1) Use the software with below versions.
V-SFT-6 Ver. 6.0.32.0 – Ver. 6.0.34.0
V-SFT-5 Ver. 5.4.45.0
- 2) Fuji Electric PLC "MICREX-SX" is selected with [N mode] or [F mode] at the connecting device setting of V-SFT. (Fuji Electric's PLC programming software "SX-Programmer Standard" is used. If the programming software "SX-Programmer Expert" is used, the problem will not occur.)
- 3) On the PLC side, set [I/O extension mode: None] for the remote I/O master module.
- 4) In the PLC system configuration, the SX station # for the remote I/O master module is smaller than the one for the direct connection I/O module.,

5) X/Y device of the direct connection I/O module is used in the HMI screen program.

The problem will be solved by transferring the HMI screen program with V-SFT Ver.6.0.35.0/Ver.5.4.46.0.
